Bonded Repairs to RAN FFG Superstructure-Strain Gauge Data Analysis

Ship Structures and Materials Division Aeronautical and Maritime Research Laboratory

DSTO-RR-0046

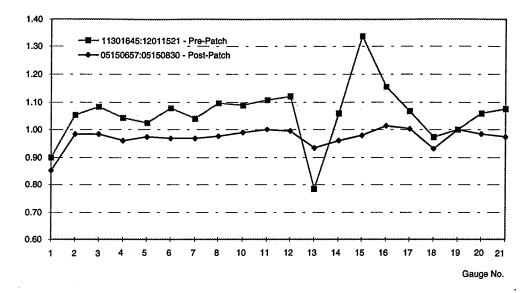
Figure 2. Normalised RMS Strain Ratios without Patch Influence

In Figure 2 most values lie within \pm 10% of 1.0 and for the post-patch comparison most are within \pm 5%. The results are more widely varied for the pre-patch comparison (11301645:12011521) where there is variation in forward speed of between 7 to 24 knots, and a variation in observed sea state of SS 3 to SS 5. In the post-patch comparison (05150657: 05150830) there is a 3 knot variation in forward speed, the sea conditions are essentially identical as the two runs are only 90 minutes apart. It would seem therefore that the differences in speed and sea conditions have a significant effect on the accuracy of the comparison method, however it is not possible to quantify these effects due to the lack of detailed wave information, particularly directional wave spectra.

In Figure 2 gauges 13, 15 and 16 all show a fairly high variations above and below 1.0 and again this is due to the fact that these gauges are not fully correlated with gauge 19, as can be seen in Table 2. These gauges, plus gauge 18, form the ±45° arms of rosettes on the deckhouse sides at the frame 196 knuckle and so measurements are

During the preparations for application of the patch a crack was found on the starboard side of 02 deck at the forward end of the insert plate, i.e. approximately frame 192-193, and was subsequently weld repaired. This will obviously affect the preand post-patch comparison unless the crack developed between the time the pre-patch trials were conducted and the application of the patches. It is believed that the crack was present at the time of the pre-patch trials and that this is the cause of the large difference between the results for the starboard rosette (13,14 and 15) and the port rosette (16,17 and 18) in Figure 2.

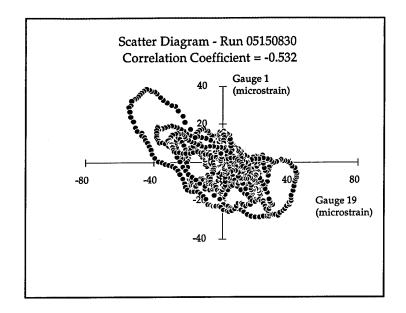
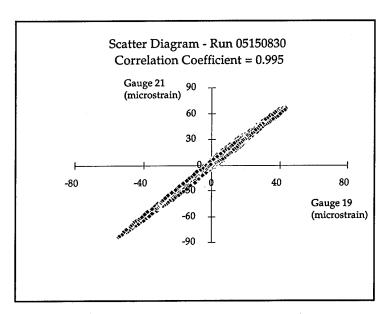
Figure 3. Scatter Diagrams - Gauges 1 and 21 Plotted against Gauge 19.

The lack of correlation between gauges 1 and 19 during run 05150830, for example, is clearly demonstrated in the scatter diagram shown in Figure 3. Gauge 1 measures pure lateral bending whereas gauge 19 measures pure longitudinal bending and as can be seen there is little correlation between the two gauges. Gauges 21 and 19 however, which both measure longitudinal bending, have a much greater correlation and so the relationship between the two gauges virtually follows a straight line. It is of interest to note in Figure 3 that strain levels for gauge 19 are approximately half the strain level of gauge 21 at the corresponding time. Gauge 21 measures strain in the hull at the main deck whilst gauge 19 measures strain just above the main deck in the superstructure side shell plating, so the distance of both gauges from the neutral axis is almost the same and so similar strains are expected. The large difference between the two indicates that there is not full transfer of load from the hull to the superstructure, possibly due to shear lag effects.

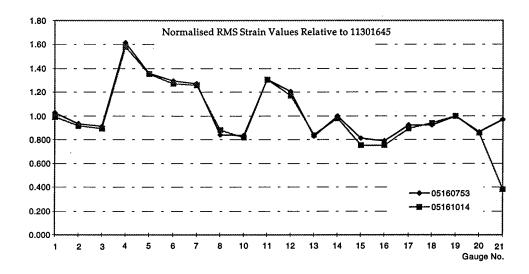
Figure 4. Change in Relative Normalised RMS Levels - Head Seas Case 1 (Values greater than 1.0 indicate an increase in post-patch level)

The ratios of the post-patch normalised RMS values compared to the pre-patch values for the data sets detailed in Table 1 are presented in Figures 4, 6 and 8. For the first of the head seas comparisons (Figure 4) the two curves are virtually identical which indicates that the effect of the patch is the same for both comparisons. The two sets of post-patch data were recorded only 2 hours apart so the sea conditions are reasonably similar and there is only a 5 knots difference in ship's speed. The only notable difference between the two curves is gauge 21 and the reasons for this were explained earlier. The reason for the large difference between the results for gauges 4 and 5 (which are respectively below and above the 02 deck) is not known but there is a consistent difference throughout and it is probably a result of the weld repair.

The differences between gauges 4 and 11 and between 6 and 12 indicates that there is a greater post-patch change in strain levels on the starboard side. This is due to the weld repair of the crack in 02 deck at the time of the patch installation. The crack was present during the pre-patch trials as seen in Figure 5 where the pre-patch strain levels for gauge 4 are approximately 50% of those for gauge 11, while for the post-patch they are almost identical. On the relative basis used for comparison the post-patch results for the starboard gauges 4 and 6 are therefore significantly higher.

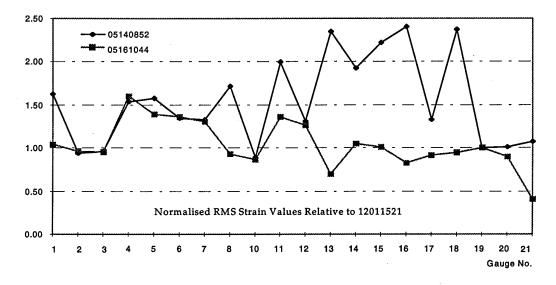
Figure 6. Change in Relative Normalised RMS Levels - Head Seas Case 2 (Values greater than 1.0 indicate an increase in post-patch level)

In the second of the head seas comparisons, Figure 6, the results vary quite substantially. The curve for run 05161044 is quite similar in shape and magnitude to the values plotted in Figure 4 while the curve for 05140852 is markedly different. Strain spectra and scatter diagrams have been produced for many of the cases

presented in Figure 6 but these have provided no insight as to why there is such large variability between the two curves. It is believed that the main reasons for this are that drift in the mean strain level and the influence of lateral bending have relatively greater influence due to the low strain levels recorded during run 05140852. An increase in lateral bending of around 70% for gauge 1 in run 05140852 suggests that lateral bending should have greater influence than for other runs.

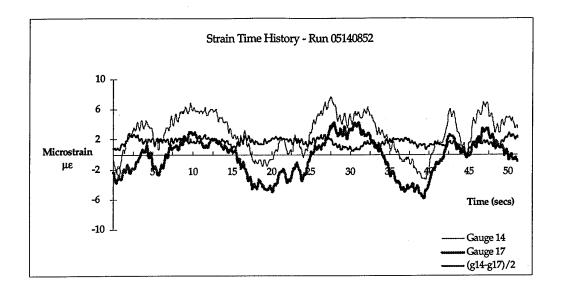
Figure 7. Strain Time History Gauges 14 and 17 Showing Lateral Bending Component

Figure 7 shows the first 50 seconds of the strain time histories for gauges 14 and 17 which form the horizontal arms of the rosettes on either side of the ship at frame 196. It is seen that the levels of strain are very low and that the lateral bending (the average of the difference between the two gauges) is about 15% to 20% of the total recorded strain. The two strain records are also offset from one another with the gauge 14 record

obviously not symmetric about zero. Since the strain record has been numerically adjusted to give a zero mean (based on a larger time duration than that shown in Figure 7) the offset shows that mean value over a short period of time is somewhat different from the mean for the total record. This is an indication of either instrument drift or changing conditions during the trial.

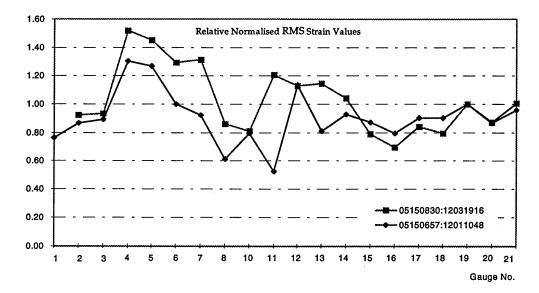
Figure 8. Change in Relative Normalised RMS Levels - Port Bow Seas (Values greater than 1.0 indicate an increase in post-patch level)

The port bow seas comparisons from Table 1 are both shown in Figure 8 and while the two cases are not identical they show similar results for many gauges and the shapes of the curves are for the main similar to those in Figure 5. The comparison 05150830:12031916 generally shows higher increases in relative RMS values than does 05150657:12011048 although variations from 1.0 are generally smaller than those for the head seas case (Figure 5). The greatest differences between the two comparisons are for gauges 7, 11 and 13 where the relative changes are in opposite directions. For the comparison 05150830:12031916 there is an increase in relative stress levels while for 05150657:12011048 reduced strain levels are indicated. The levels of strain recorded during run 12031916 are quite low in comparison to other runs in Figure 8 so the results are likely to be affected for similar reasons to that detailed above.

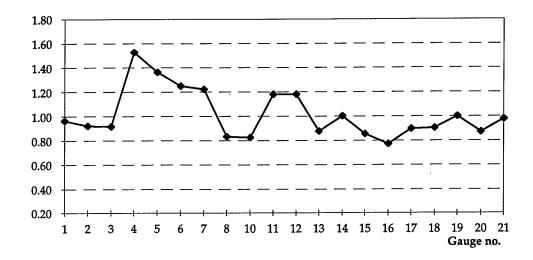
Figure 9.. Average Relative Normalised RMS Changes (Excluding Run 05140852) (Values greater than 1.0 indicate increase in post-patch level)

Figures 4,6, and 8 above are plotted in Figure 9 and are shown diagrammatically in Figure 10. The results for gauge 21 relating to runs 05161014 and 05161044 are considered anomalous and so as not to distort the average these are excluded from Figures 9 and 10.

Gauge 1 results are difficult to assess with any confidence because of the lack of correlation between lateral and longitudinal bending. The lateral bending mode has been shown to have virtually no correlation with the longitudinal bending mode and so assessment based on the above results is risky. Because of the increased section inertia provided by the patches there is likely to be a small drop in strain levels, however this drop will only be small, and from Figure 9 this seems to be the case.

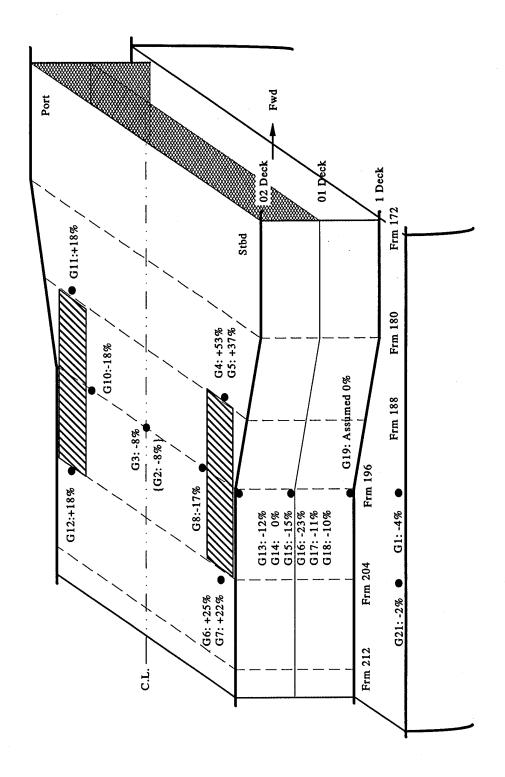
Figure 10. Average Changes in RMS Strain - Relative to Pre-Patch Levels

Gauges 4, 5, 6, 7, 11 and 12 which are located on the upper and undersides of 02 deck along the patch centrelines, show increases of between 20% and 60% from the prepatch to the post-patch trials. An increase in strain at these locations is to be expected as the load carried by the patch must be dissipated into the deck at either end of the patch and so the strains in these locations will increase. The largest increases appear to occur during the head seas cases. The asymmetry between port and starboard results is believed to be due to the weld repair of a crack on the starboard side of 02 deck at Frame 192-193 just prior to the application of the patches. Gauges 4 and 5 seem to be most affected by the weld repair, although the slightly greater post-patch relative strain levels for gauges 6 and 7 compared with gauge 12 show that these gauges are also affected.

Gauges 8 and 10 measure strains alongside the mid-span of the patches and are located on the underside of 02 deck inboard of the patches. There is a reduction in strain levels of around 10%-20% at these locations and again although the gauges are located at nominally identical positions on either side of the ship and their results are similar in most instances, post patch strain levels are often lower for gauge 10 (port side). However the results are not consistent, for example run 05150657 shows a 40% reduction for gauge 8 and not for gauge 10, while for run 05140852 there is an apparent 60% increase for gauge 8 but not for gauge 10. The results for the rosettes located at the frame 196 knuckle (gauges 13, 14, 15 and 16, 17, 18) are erratic with sometimes large variations between results across different trials, although on average a reduction of up to 23% is indicated. Results would probably be clearer if the rosette strains were converted to principal strains for the comparison, however the analysis software requires modification before this can be done. Results for the starboard side show about a 5% greater strain reduction compared to the port side. It is likely therefore that the results are influenced by both the patch and the weld repair on 02 deck, and that the patches have produced a reduction of up to 15% in some cases, although for principal strains this is would likely be lower.

- Further enhancements to the data analysis software are required, namely transformation of rosette strains to principal strains, filtering of background noise and correction for low frequency drift.
- An analytical analysis, using the Finite Element Method, to enable patches to be tailor made so as to minimise any stress increases is strongly recommended.
